Connecticut Coastal Structures Inventory Study

SECTION 22
CONNECTICUT COASTAL STRUCTURES INVENTORY STUDY

PHASE I - NEW LONDON COUNTY

APPENDIX D
ATLANTIC QUADRANGLE
RECORDS OF STRUCTURES WITH PHOTOGRAPHS

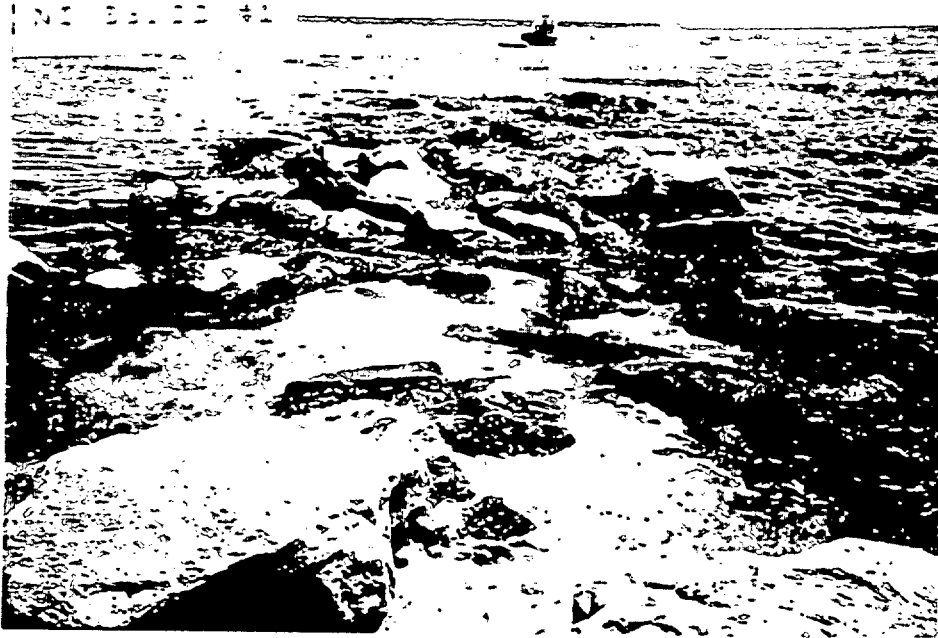
TYPE OF STRUCTURE: GROIN CONDITION: POOR
MAIN FUNCTION : PROTECTION OF BEACH AREA
MATERIAL : STONE

GROIN NOT EFFECTIVE. SHORE: LINED WITH STRUCTURES

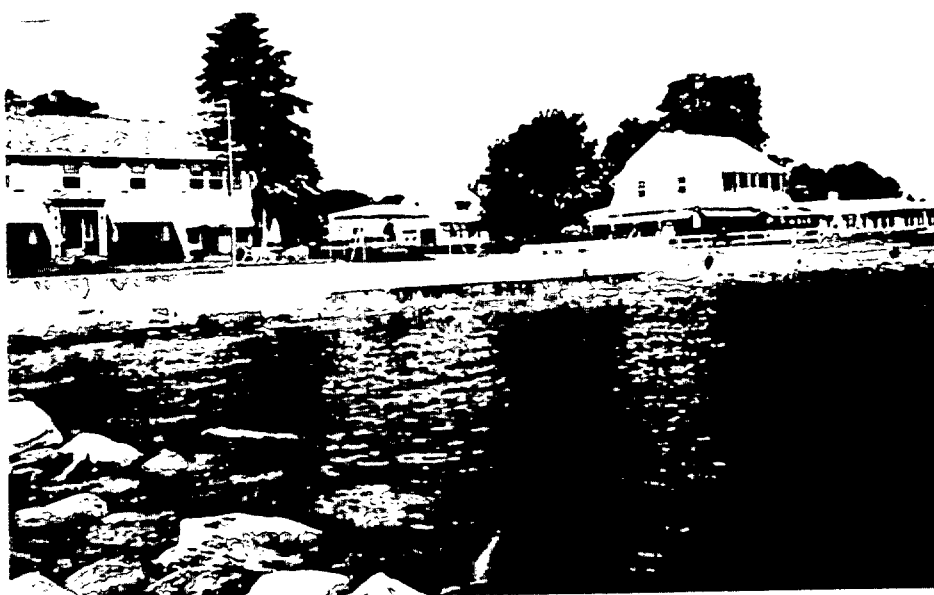
NI 91.00 #1

SANDY BEACH TO NORTH. SOUTH END HAS BEEN REBUILT IN STONE,
PROBABLY DUE TO STORM DAMAGE.

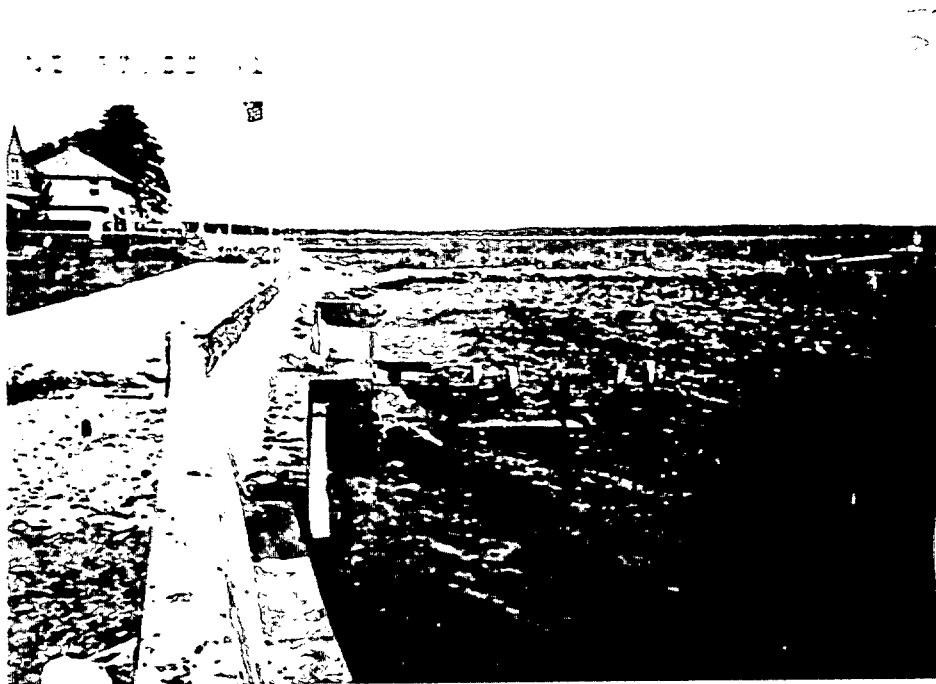
TYPE OF STRUCTURE: SEAWALL CONDITION: GOOD
MAIN FUNCTION : RETAINS LAND/ PREVENTS EROSION
MATERIAL : STONE/CEMENT

SHORE: LINED WITH SEAWALLS AND BULKHEADS

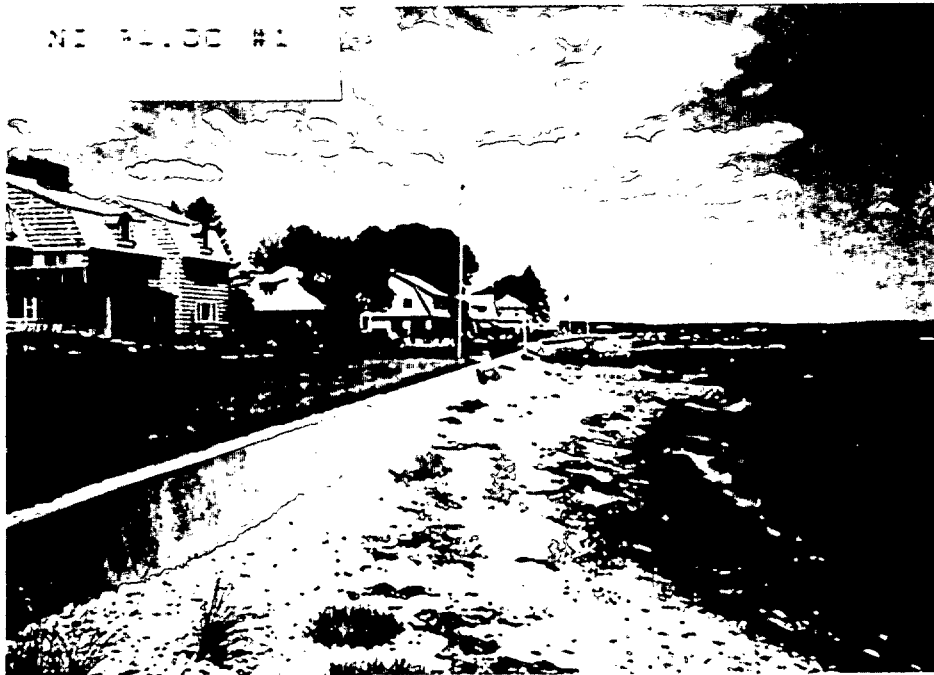
TYPE OF STRUCTURE: SEAWALL CONDITION: GOOD
MAIN FUNCTION : RETAINS PROPERTY/ PREVENTS EROSION
MATERIAL : CONCRETE

SHORE LINED WITH STRUCTURES TO NORTH. SANDY/PEBBLY BEACH IN
FRONT AND TO THE SOUTH.

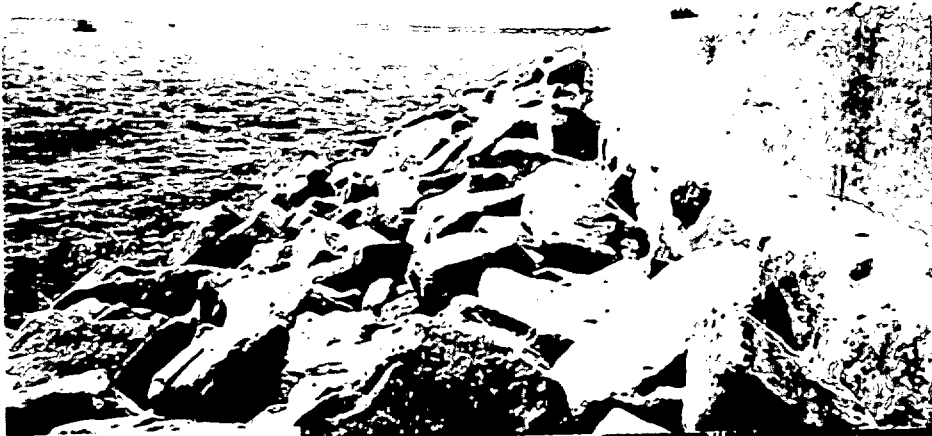
TYPE OF STRUCTURE: SEAWALL CONDITION: FAIR
MAIN FUNCTION : RETAINS LAND/PREVENTS EROSION
MATERIAL : CONCRETE/STONE

SHORE: ROCKY. SOUTHERN HALF ALSO PROTECTED BY RIPRAP IN
FRONT OF WALL.

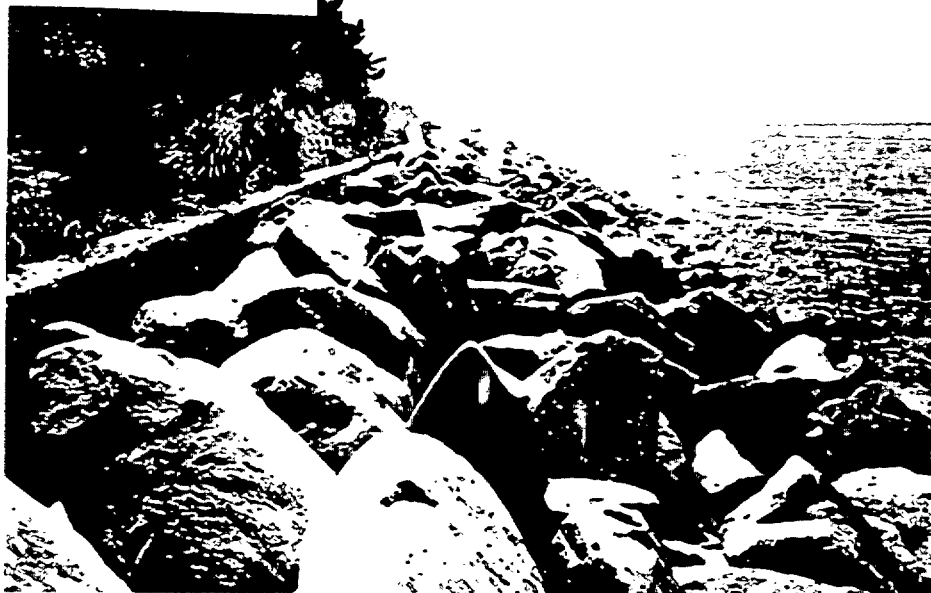
NI 103.00 #1

TYPE OF STRUCTURE: SEAWALL/RIPRAP CONDITION: FAIR
MAIN FUNCTION : RETAIN LAND/PREVENT EROSION
MATERIAL : CONCRETE& STONE

SHORE: ROCKY

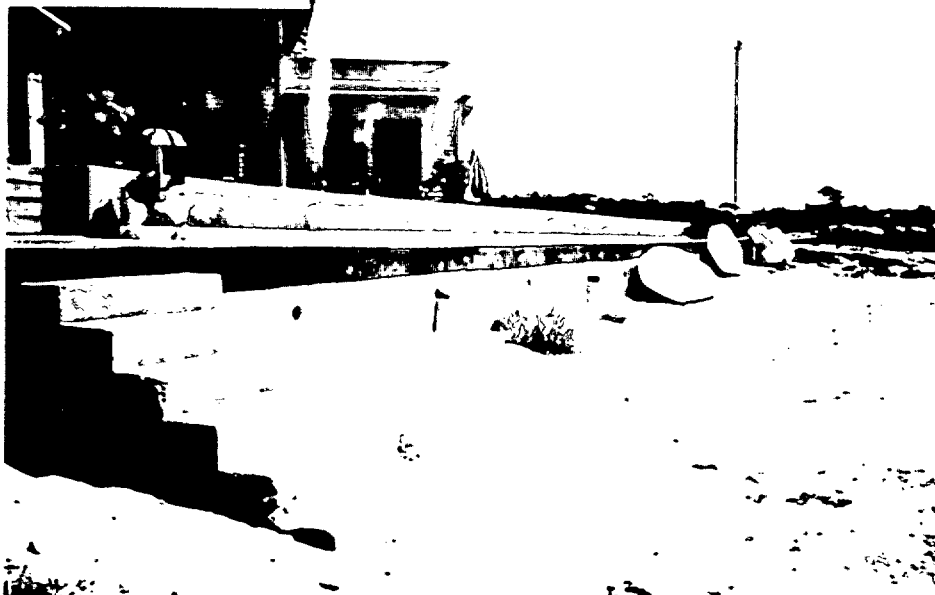
NI 109.00 #1

TYPE OF STRUCTURE: SEAWALL CONDITION: GOOD
MAIN FUNCTION : RETAINS PROPERTY
MATERIAL : CONCRETE

SHORE: SANDY BEACH

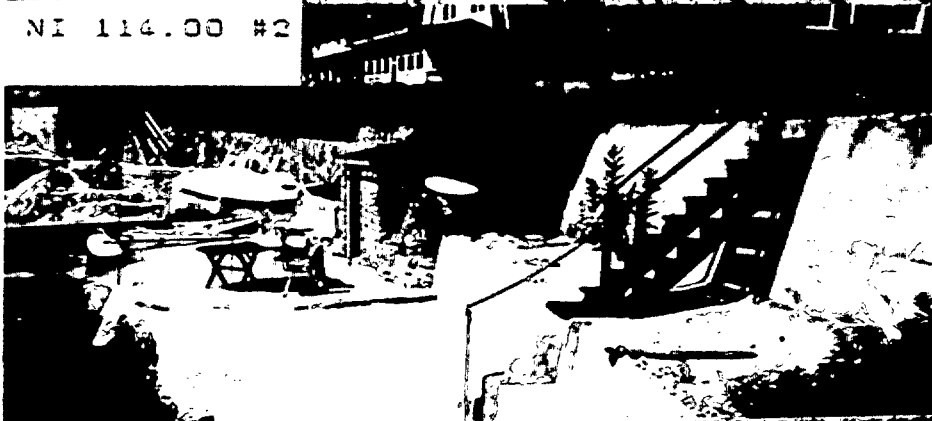
TYPE OF STRUCTURE: SEAWALL CONDITION: FAIR
MAIN FUNCTION : PROTECTION FROM WAVE ACTION
MATERIAL : STONE IN CEMENT

NORTH END OF WALL BEING UNDERMINED. SHORE: ROCK AND EXPOSED
BEDROCK.

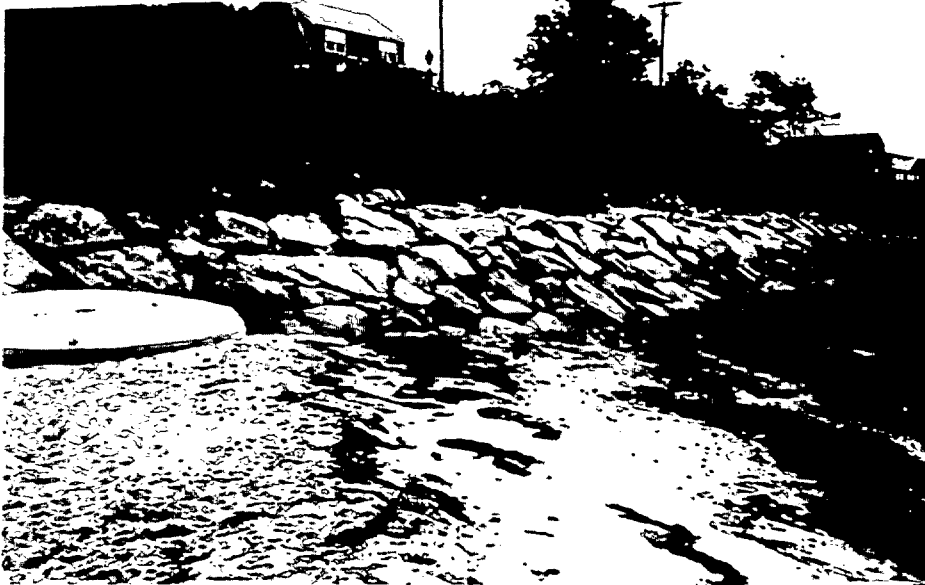
NI 117.30 #1

TYPE OF STRUCTURE: REVETMENT CONDITION: GOOD
MAIN FUNCTION : PROTECTION OF SLOPE
MATERIAL : QUARRY STONE

SHORE: SANDY WITH SMALL COBBLES

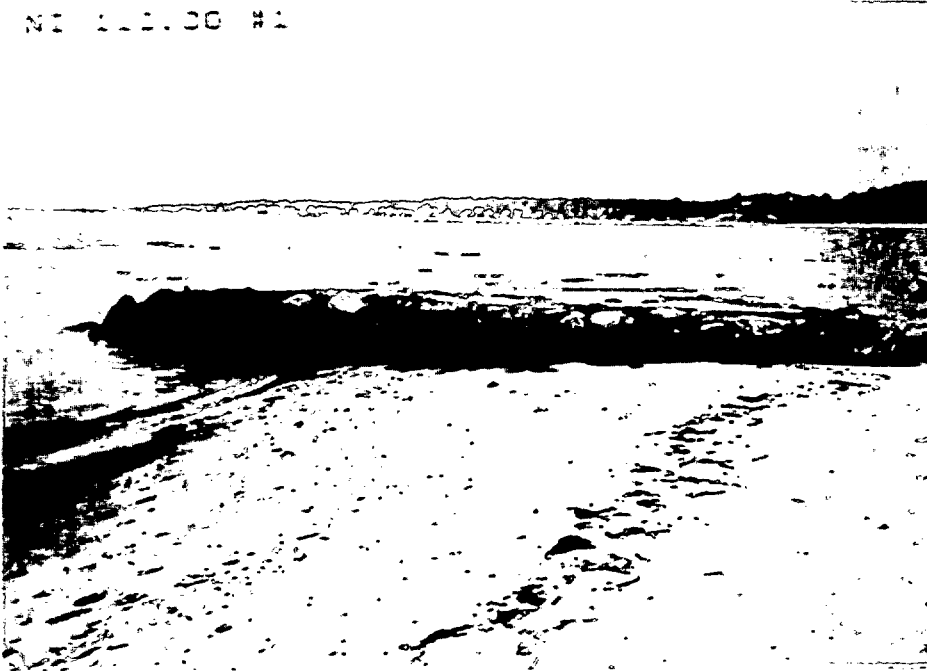
NI 111.00 #1

TYPE OF STRUCTURE: GROIN CONDITION: GOOD
MAIN FUNCTION : PROTECTION OF BEACH TO EAST AND WEST OF GROIN?
MATERIAL : STONE IN CEMENT

SHORE: SANDY BEACH TO EAST AND WEST. MORE SAND ON EAST SIDE
PRIVATE BEACH

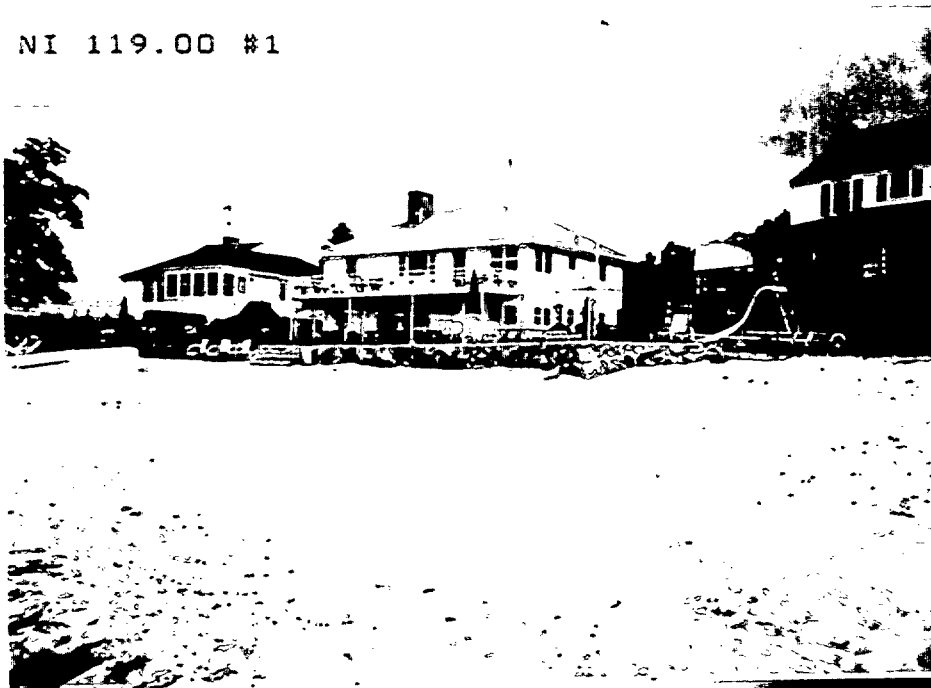
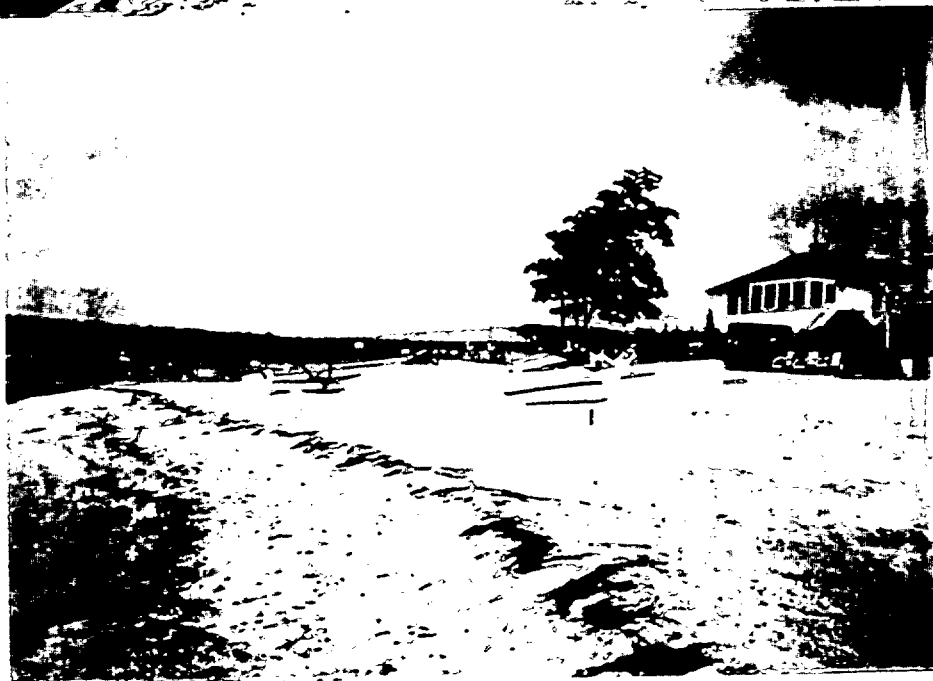
NI 119.00 #1

TYPE OF STRUCTURE: SEAWALL CONDITION: FAIR
MAIN FUNCTION : RETAIN FILL BEHIND WALL
MATERIAL : STONE IN CEMENT

75 FEET OF SANDY BEACH SHORE

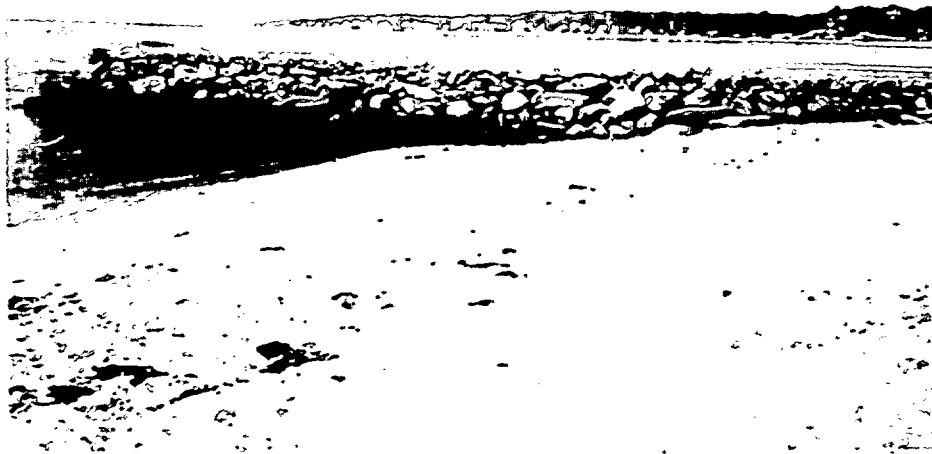
NI 120.00 #1

TYPE OF STRUCTURE: GROIN CONDITION: GOOD
MAIN FUNCTION : PROTECTION OF SANDY BEACH AREA
MATERIAL : STONE IN CEMENT

SANDY BEACH AREA 100 FT OF BEACH. PRIVATE AREA TO EAST OF
GROIN, ROCKY NECK STATE PARK TO WEST OF GROIN.

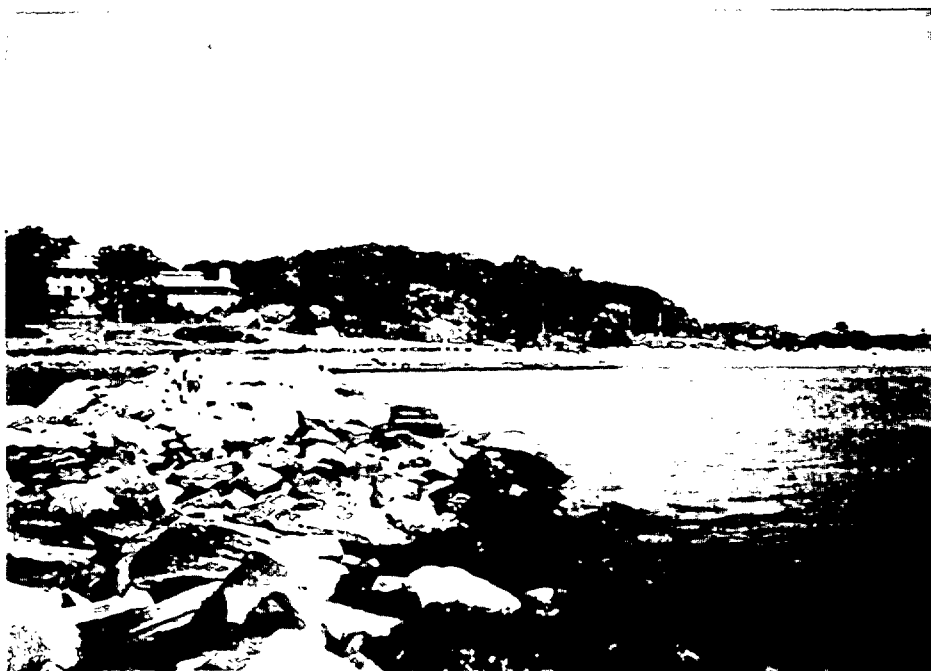
TYPE OF STRUCTURE: RIPRAP CONDITION: GOOD
MAIN FUNCTION : STABILIZATION OF SHORE AT PICNIC AREA
MATERIAL : QUARRY STONE

A black and white photograph showing a rocky shoreline in the foreground. A body of water, possibly a lake or a wide river, occupies the middle ground. In the background, there is a small, light-colored building with a dark roof, surrounded by trees and vegetation. The sky is bright and appears overexposed.

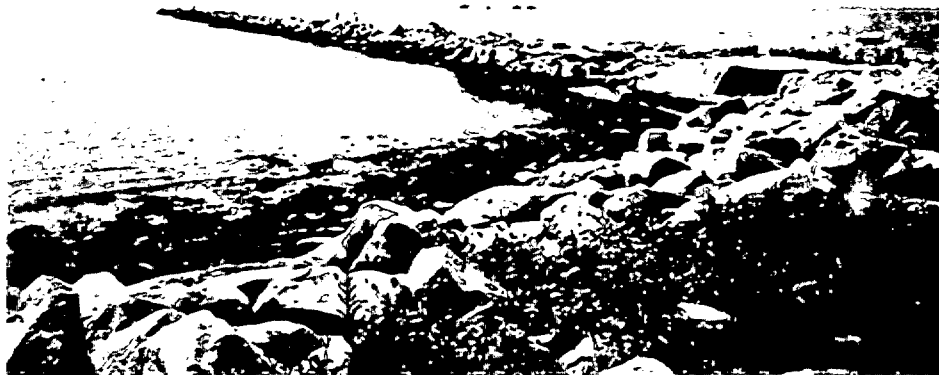
NI 102.00 #1

TYPE OF STRUCTURE: BREAKWATER CONDITION: GOOD
MAIN FUNCTION : PROTECTION OF SANDY BEACH LOCATED TO EAST OF STRUC
MATERIAL : QUARRY STONE

SANDY SHORE TO EAST, EXPOSED BEDROCK TO WEST
ROCKY POINT STATE PARK
